REGIONAL DISTRICT OF NANAIMO  
AGRICULTURAL ADVISORY COMMITTEE  
FRIDAY, JULY 11, 2014  
2:00 PM

**French Creek Erosion Streambank Restoration, Adjacent to 2560 Grafton Avenue**  
**Grafton Avenue Photos Dec. 3, 2013**

French Creek Proposed Habitat and Stream Bank Restoration - Overall Plan

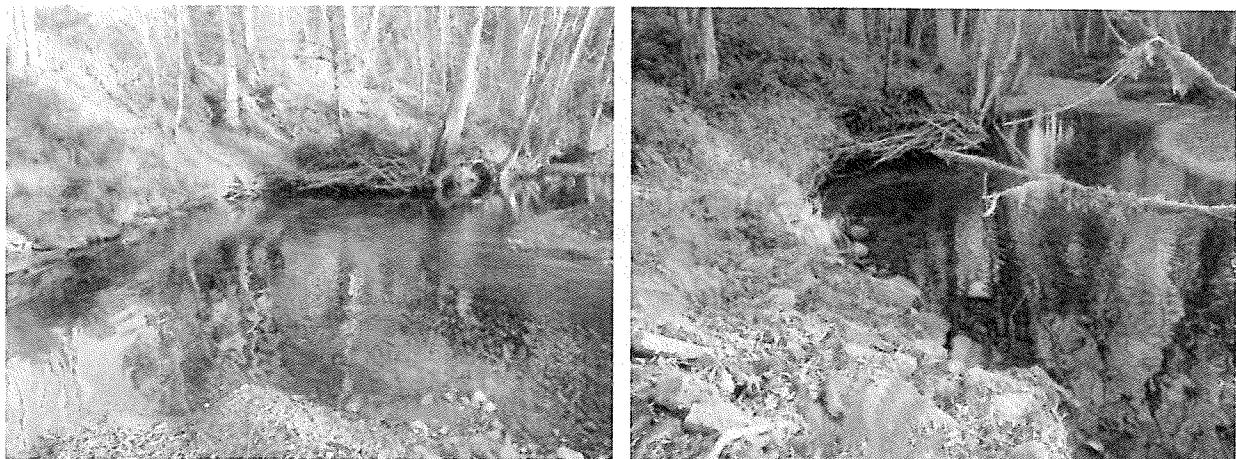
French Creek on the S side along 2560 Grafton Avenue left (when facing downstream) bank takes a hard right turn (the road appears to be built in the natural path of the stream) and reportedly has been eroding over several years. MOT District Office contacted MOT Environmental Management because of concerns the erosion is now progressing to the road toe. Previously waste concrete was placed along the bank. Given the site is not at a high or imminent risk of failure an environmentally friendly treatment using anchored large woody debris, revegetation and habitat complexing features is proposed instead of a homogeneous harder engineering type of treatment. A spawned out coho is rafted along the upstream face of the concrete and redds were visible in the vicinity.

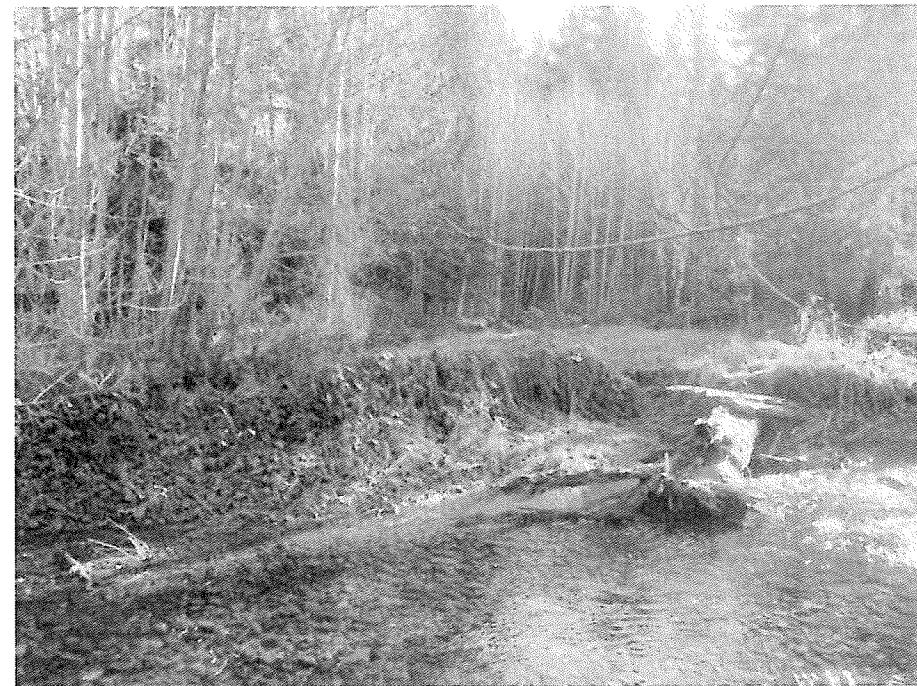
Potential offchannel area along right bank is relatively small, but provides enough room along the flat, previously cleared area to excavate to create year round aquatic habitat. Gravel is visible along the bank, which is desirable for excavation and interception of groundwater but consolidated till (hardpan) was visible in spots along the creekbed and if present in the potential offchannel area may preclude its development.

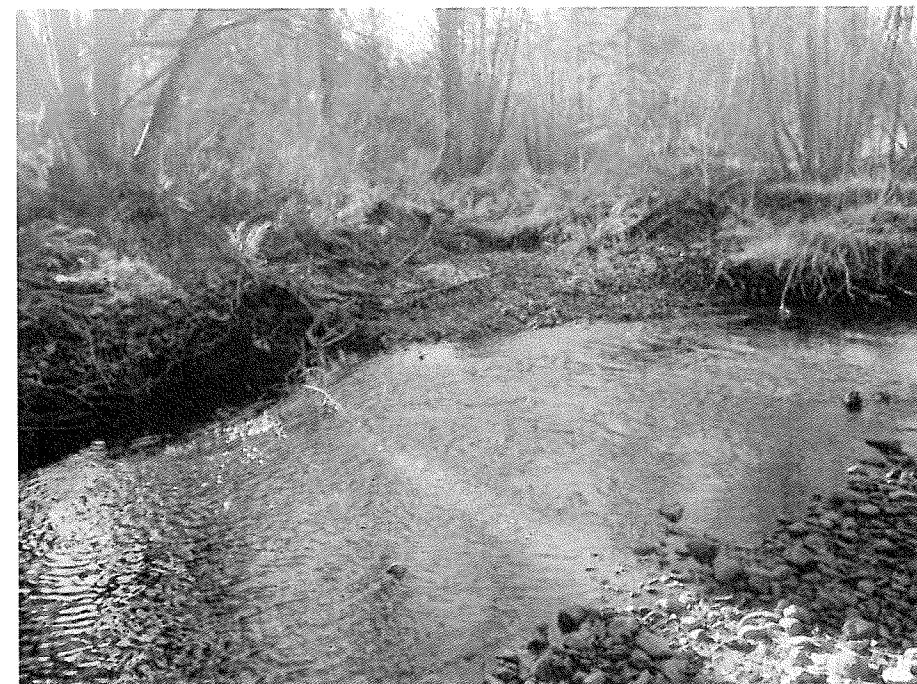
Downstream/outlet end of offchannel area shows a low spot that is likely a relief area for flood flows that overtop the bank.

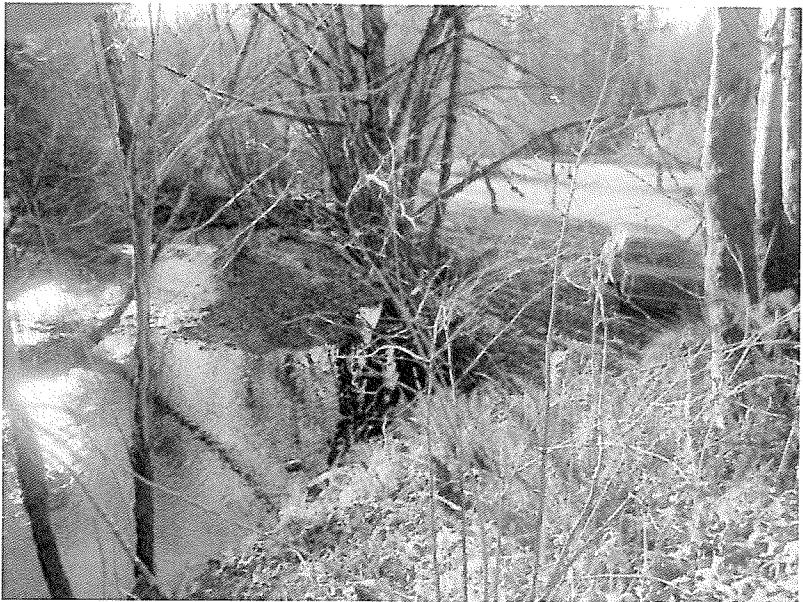
Upstream view from Grafton Avenue toward restoration zone along road toe and 2560 Grafton Ave. The parked vehicle would be removed and the landowner indicated support for riparian restoration along the top of bank. If FFC provides volunteer planting, this enhances funding eligibility for the [DFO Recreational Fisheries Conservation Partnerships Program](#) and [Pacific Salmon Foundation Community Salmon Program](#). MOT offers to draft the applications on behalf of and review by FFC prior to submission to any funding organizations.

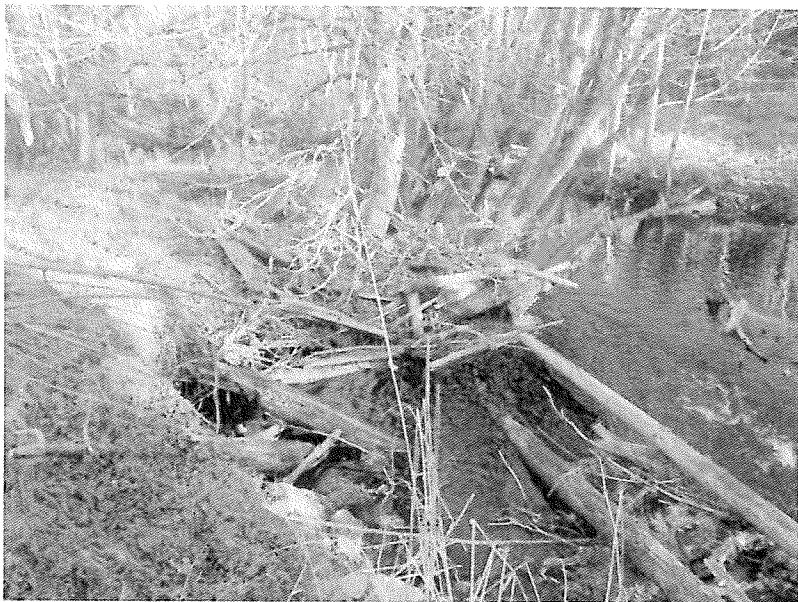
There is disturbance from clearing and fill (e.g. concrete) along 2560 Grafton Avenue upstream of the road along the left bank,. A large woody debris revetment is suggested at the location shown to prevent further outflanking that would eventually erode behind the cluster of maple trees. This area has some loose wood and a deep pool around the maple roots. The treatment would accentuate and stabilize the desirable features through anchored large woody debris that provides complexity and prevents further lateral migration behind the maple cluster.

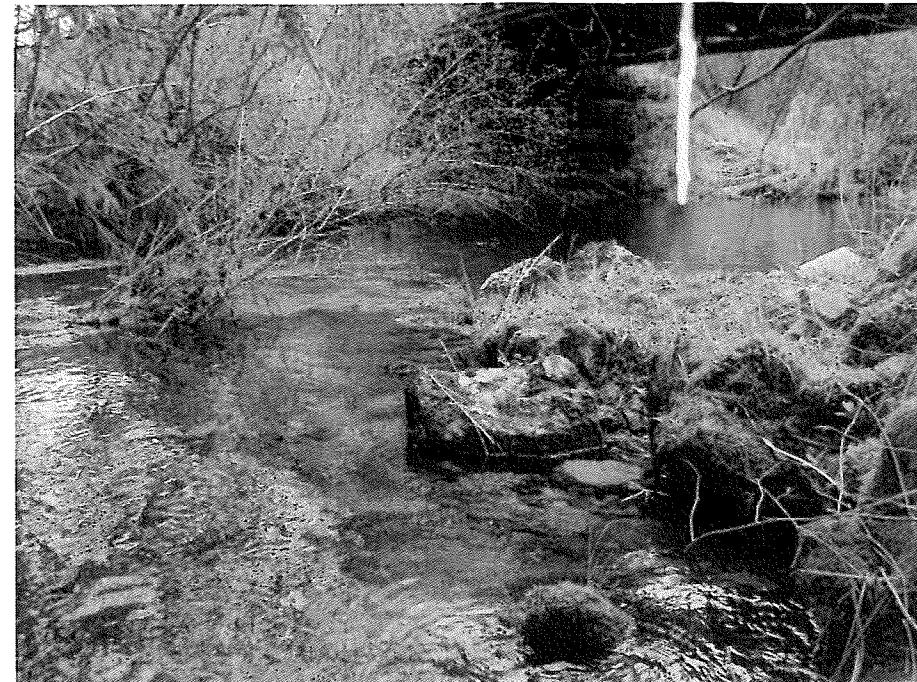
Downstream angled view along right bank abutment riprap upstream of the bridge. Note flow is deflecting off the tip of riprap and other fill that juts into the channel. This is deflecting flows toward the left bank and left bridge abutment and may be contributing to small and localized erosion.

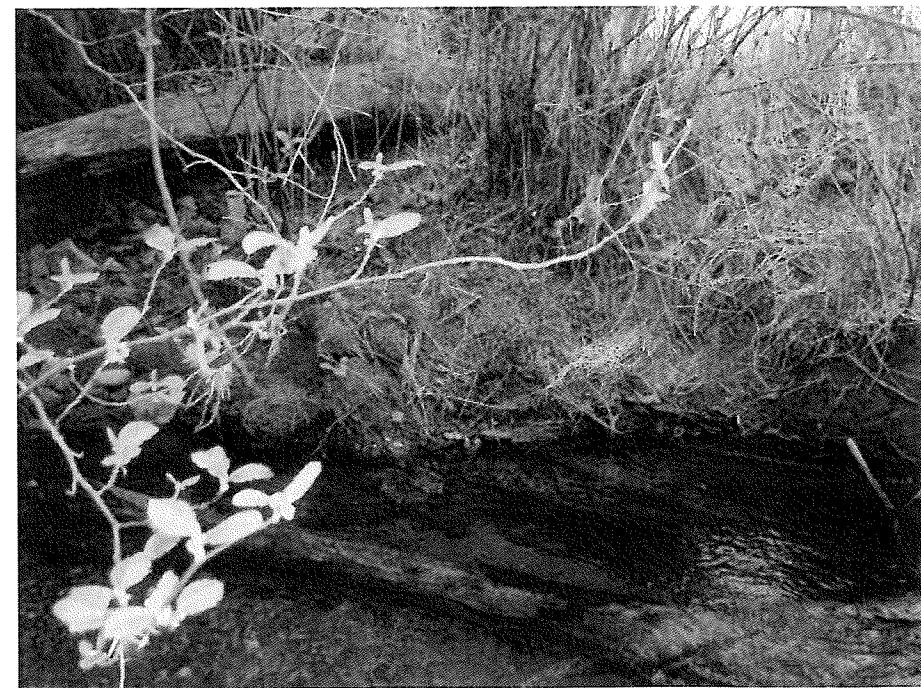
Some minor erosion and overhang along left bank upstream of bridge opposite of the right bank riprap placement. If desirable, restoration works may be done here to improve bank stability, being cognizant not to constrict the channel or catch debris. Access to this portion of the streambank is from a farm field adjacent to the bridge.

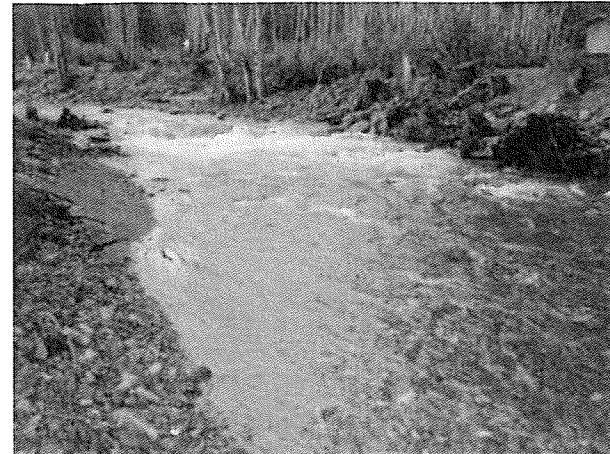
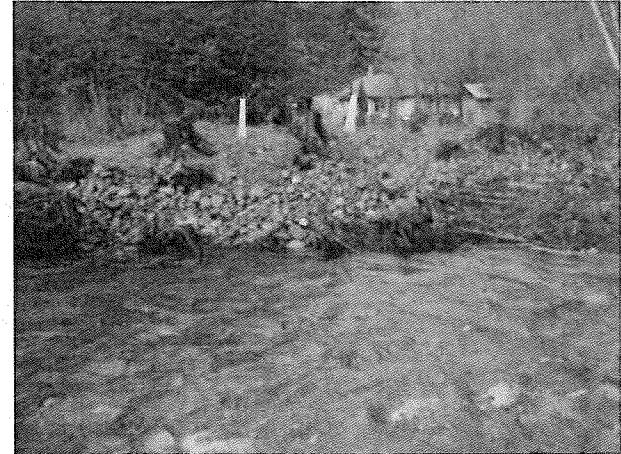
Post-restoration works have been stable and functioning as intended.

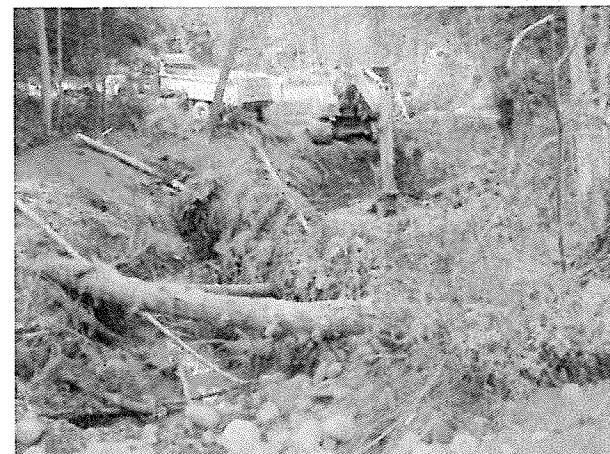
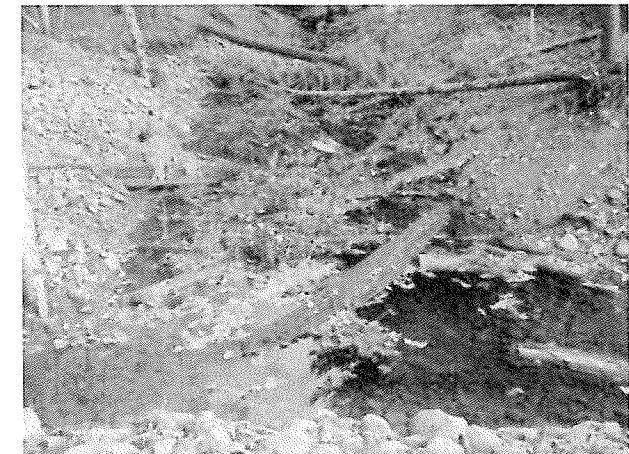
Offchannel pond construction, coho juveniles observed using the offchannel area through all seasons.
