South Wellington and Cassidy Groundwater Quality Study

Presentation to

October 19th, 2011

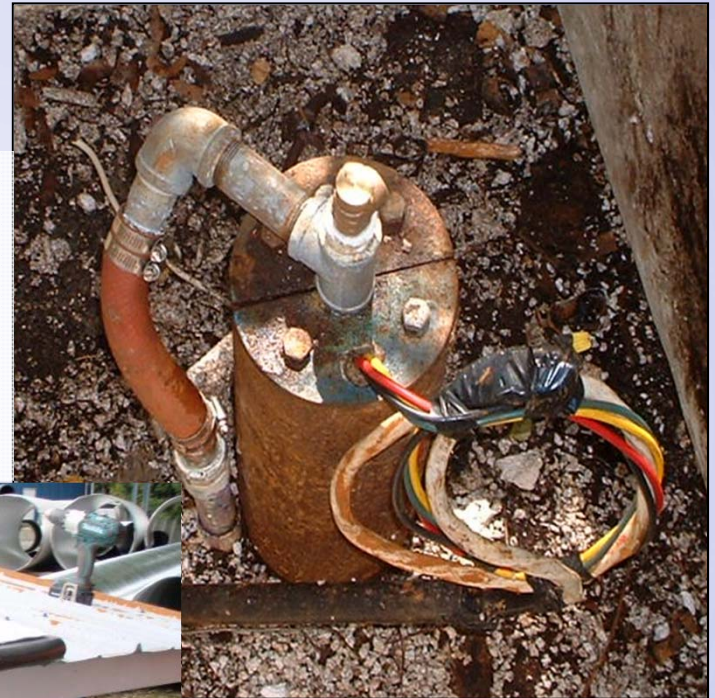
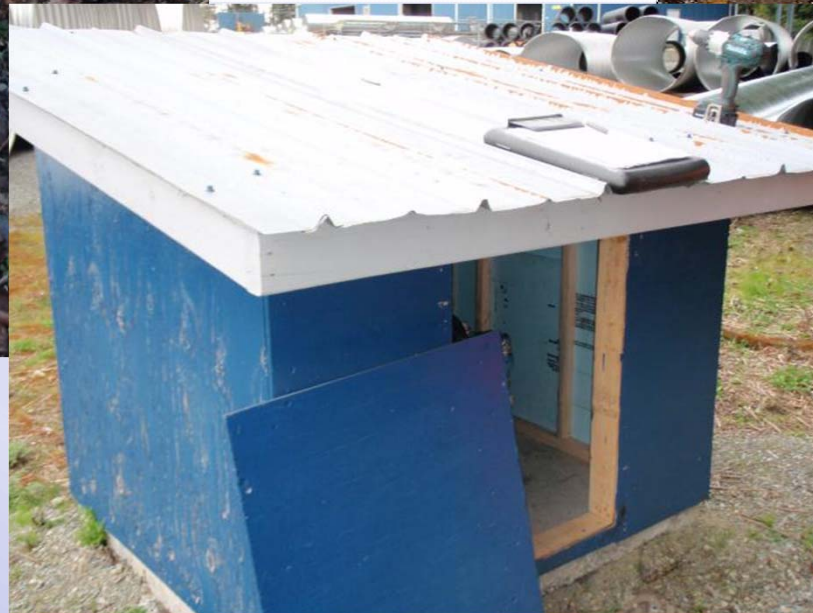
**Good
examples of
wellhead
protection**

Keep your well house, or the area around your wellhead, clean and free of chemicals and debris.

Build a well house (if needed).

Grade the ground around the wellhead so that water flows away from the well and does not allow ponding of water.

Extend the well casing at least 12" above ground level.

Installing a secure, vermin proof well cap.

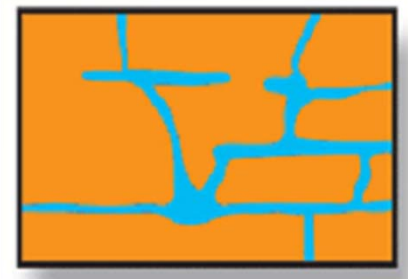
Water in rock fractures

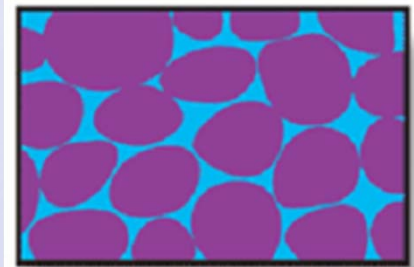
Water between grains of sand

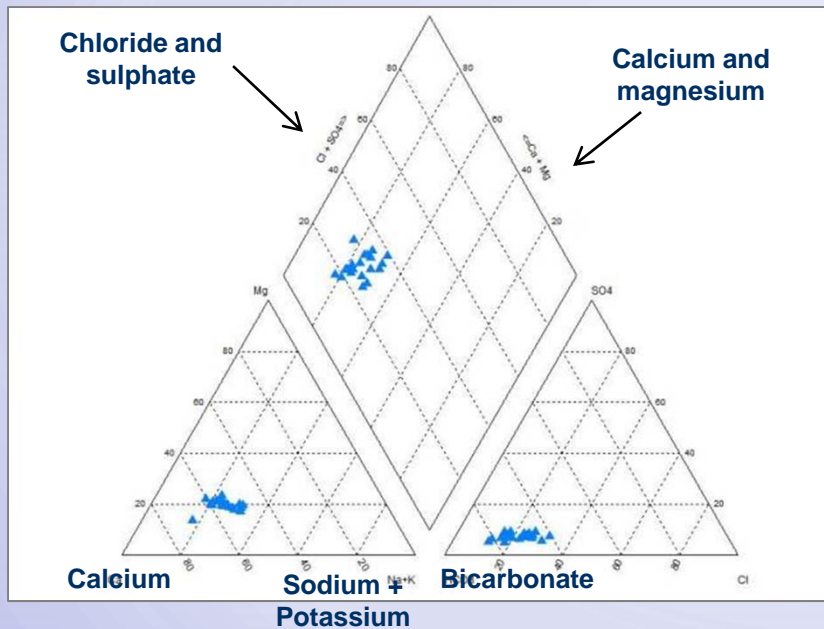
Cassidy

Very different water characteristics!
