SCHEDULE "DD": INTEGRATED STORMWATER MANAGEMENT PLAN

Final Report The Lakes District and Schooner Cove ISMP

November 21, 2013

KERR WOOD LEIDAL
consulting engineers

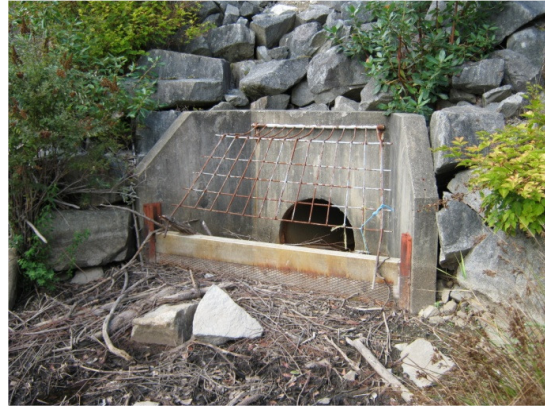
Enos Lake Outlet Structure

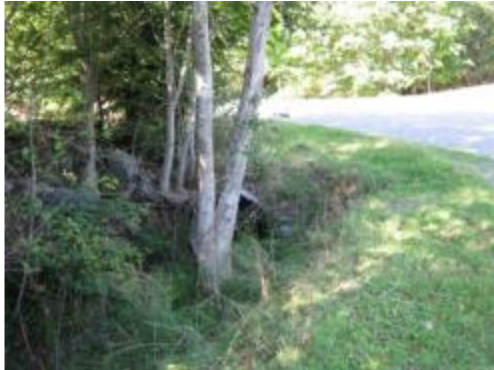
Enos Creek (S1), flows out of Enos Lake and Enos Wetland W1. The creek is about 1.5 m to 2 m wide and flows through a well-defined bedrock gully. Significant wood debris is in the channel, which most likely remains from a beaver dam breach about 13 years ago. The stream downstream of the beaver dam shows signs of erosion.

Enos Creek (S1) at Swallow Rd and Dolphin Drive looking upstream at 1,500 mm dia

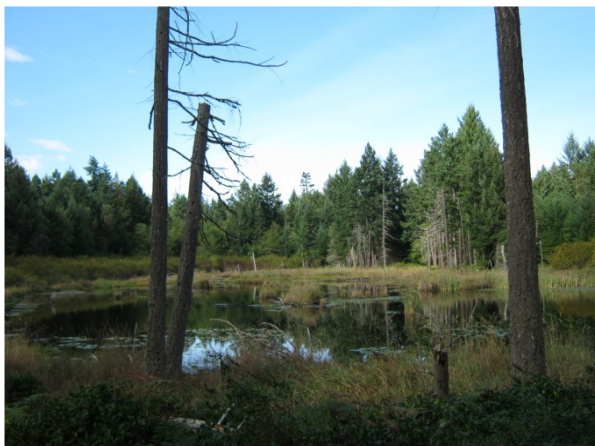
Wetland W2 on Stream S3

Stream S3 flows out of **Wetland W2** on the south-west side of Enos Lake. This wetland is located high on a bedrock ridge above the lake. The pond was formed when peat was excavated from the area and the water level has been raised about 0.5 m by a beaver dam at the outlet. There were no signs of recent beaver activity or active erosion or instability of the dam. The stream flowing out of the wetland flows over an exposed bedrock meadow and over a cliff into the lake.

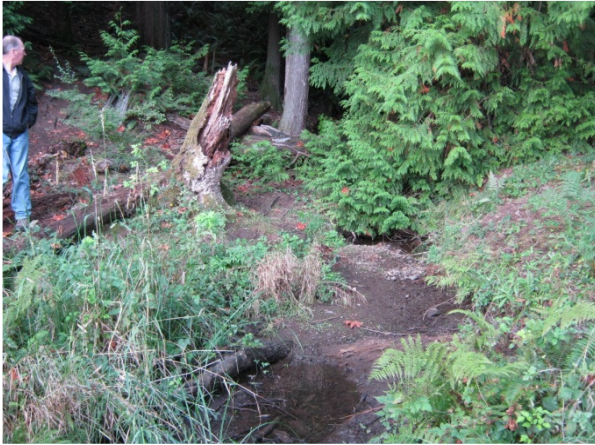
Stream S6 near Outlet to Lake

Stream S6 flows out of Wetland W4 and outlets over a 5 m high bedrock waterfall to Enos Lake. It is approximately 1 m wide and about 0.5 m deep and flows down a well-defined bedrock valley. The banks of the channel are cut into cohesive clay and glacial till soils and appear to be resistant to erosion. The banks are well vegetated, except where the stream flows through cedar groves.

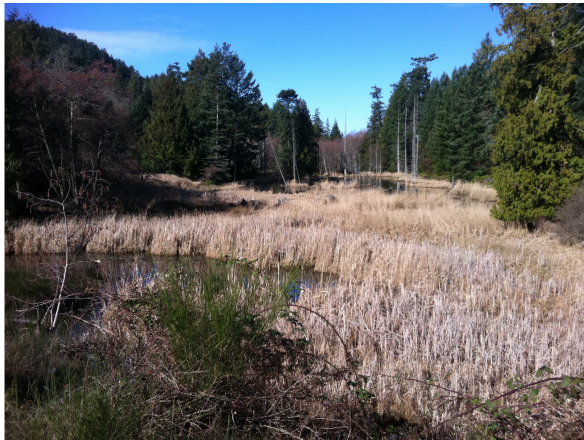
Wetland W7 flows into Enos Lake. No erosion or stability concerns were observed. There are existing stormwater detention ponds located upstream (south) of Wetland W7.

Wetland W7 located at upstream end of Enos Lake

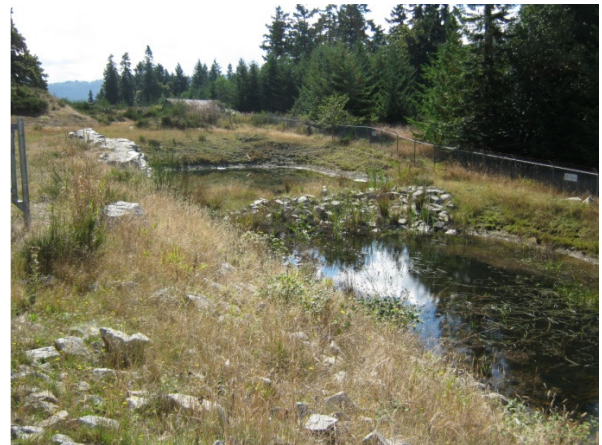
Existing stormwater detention ponds south of Fairwinds Drive

It is recommended that the existing detention ponds upstream of the wetland be expanded to provide the required 4,850 m³ detention volume to prevent negative impacts to the wetland.

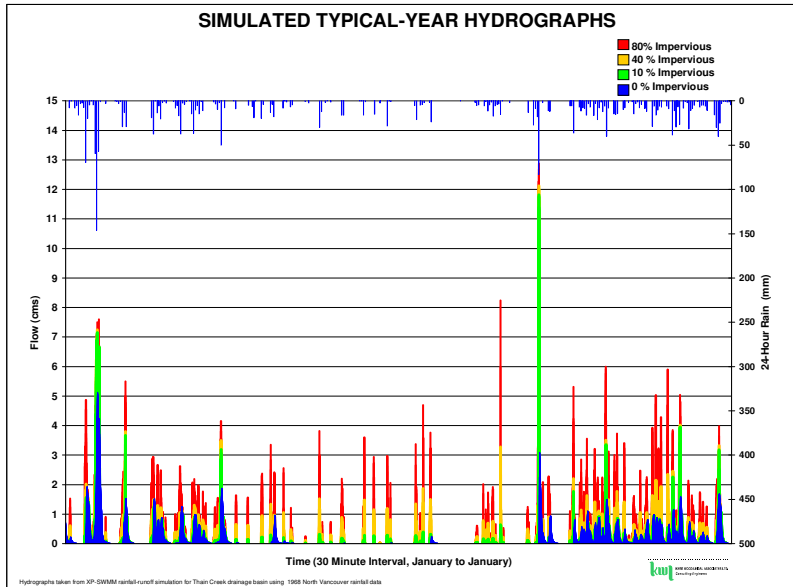
Prior to land development, minor rainfall events do not yield surface runoff. However, because of increased impermeable area, surface runoff from these minor storms is produced after land development. This is clearly shown in the typical-year hydrograph for various levels of development.

Simulated Typical-Event Hydrograph for Levels of Imperviousness

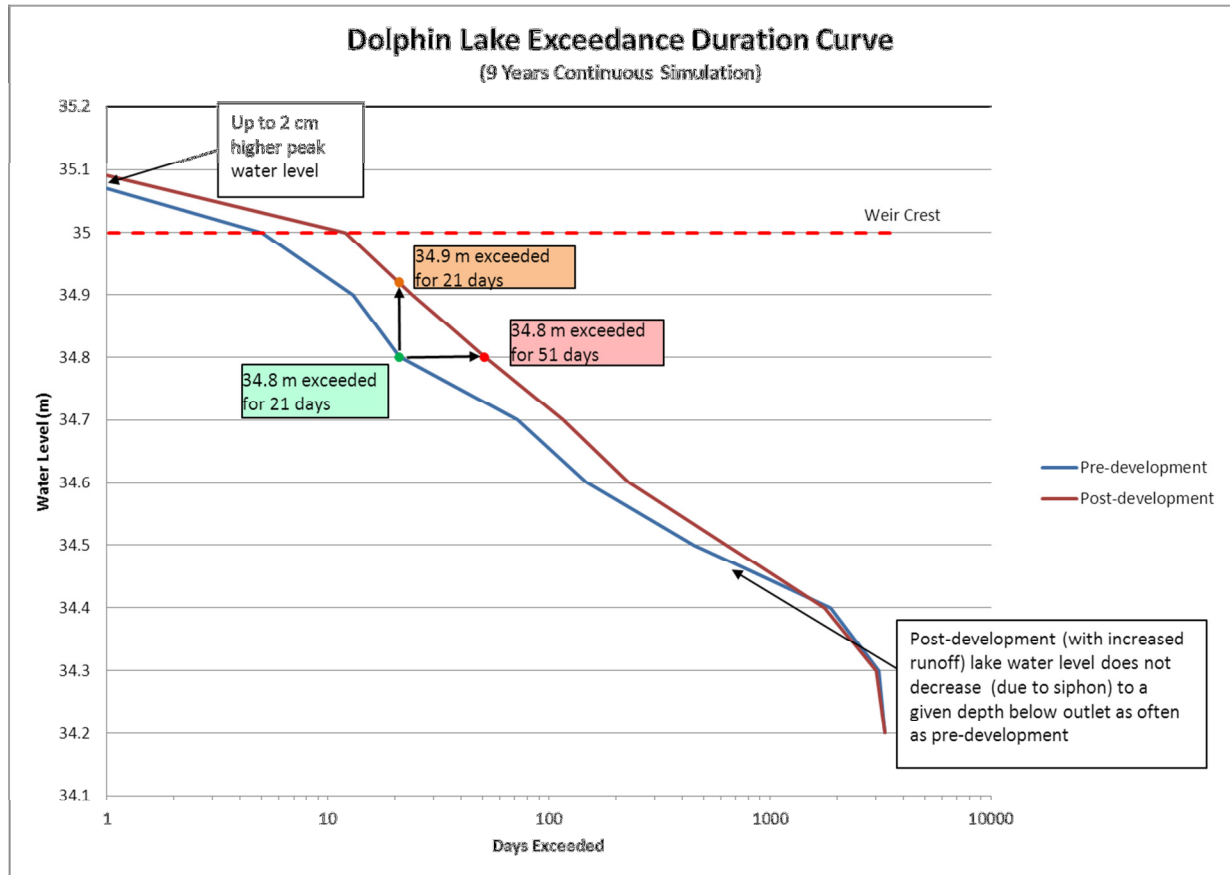
Figure A-2 – Dolphin Lake Water Level Exceedance Duration Curves

The maximum peak water level increase is approximately 7 cm higher in the post-development scenario which results in an additional 0.1 ha of lake surface area. The increased duration of given water levels generally ranges from 1 to 3 times higher during post-development - any given water level above the outlet occurs more frequently in the post-development than the pre-development.

When the 17% climate change factor is added to the rain, the peak water levels increase in the pre-development by 6 cm and in the post-development by 11 cm, while the difference in maximum peak water levels between pre- and post-development is approximately the same with and without climate change. The duration of water levels increases with climate change. The duration at any given water level for the pre-development with climate change scenario is approximately 1 to 3 times the duration of the pre-development without climate change scenario. Durations for the post development with climate change are 1 to 3 times longer than the pre-development with climate change.
